A Risk Analysis of Landslides on the Morawaka “Kanda” Area in the Matara District of Sri Lanka

S.Wijeratne

Department of
Geography,
University of Ruhuna

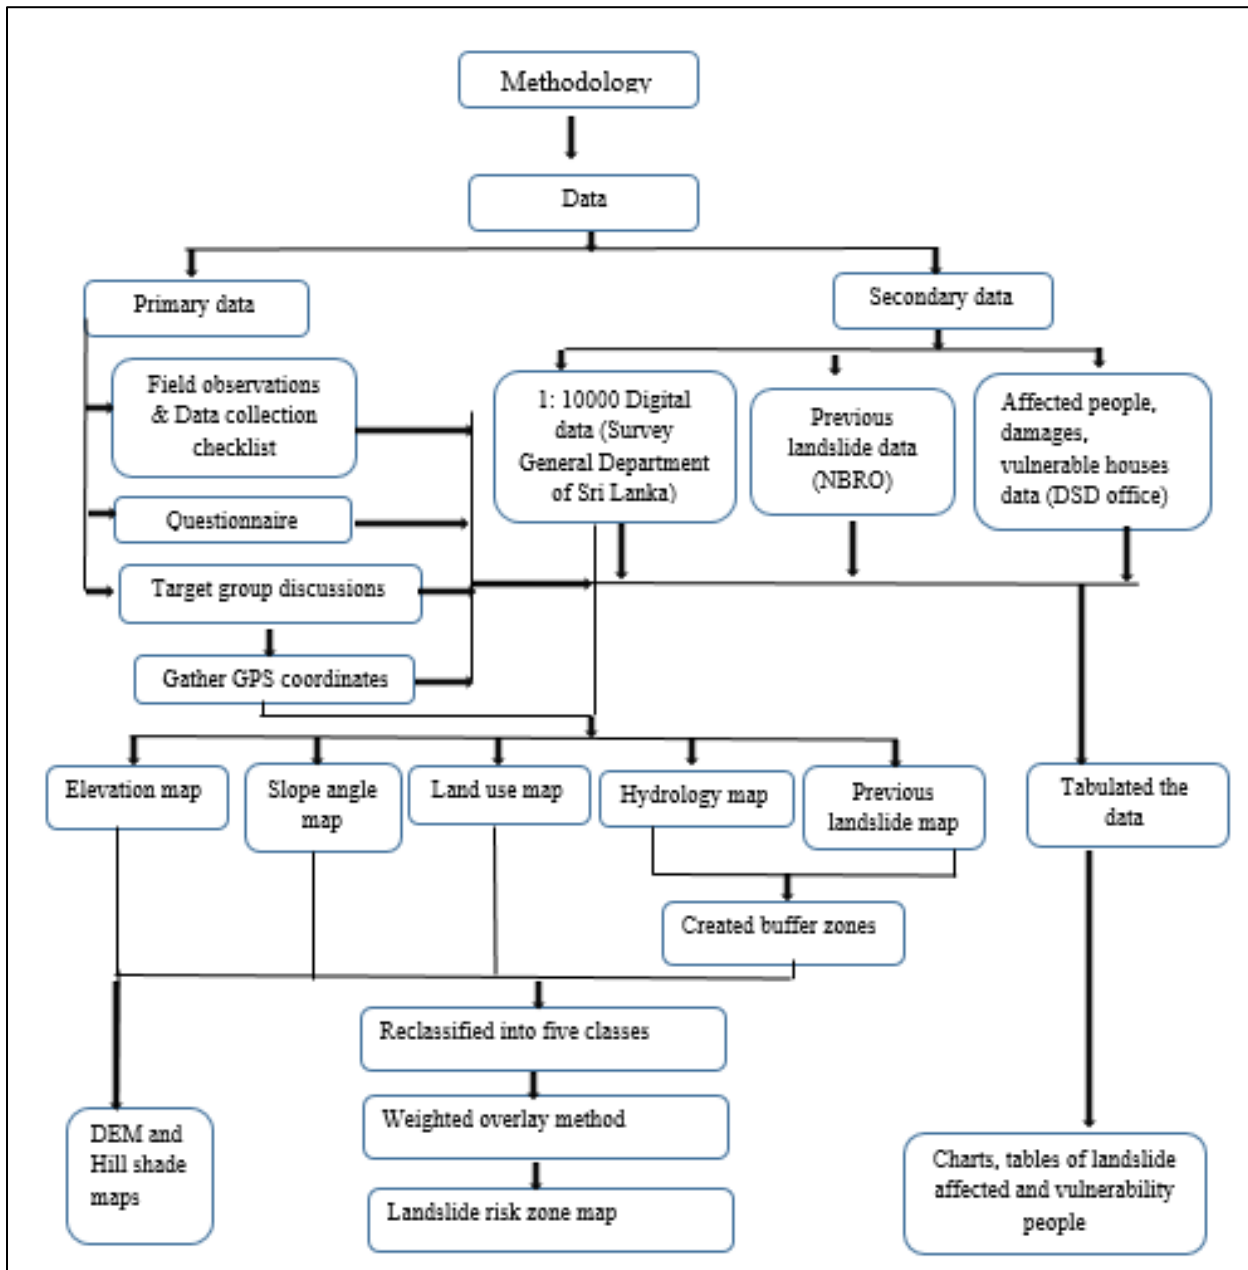
Figure 02-Research Methodology

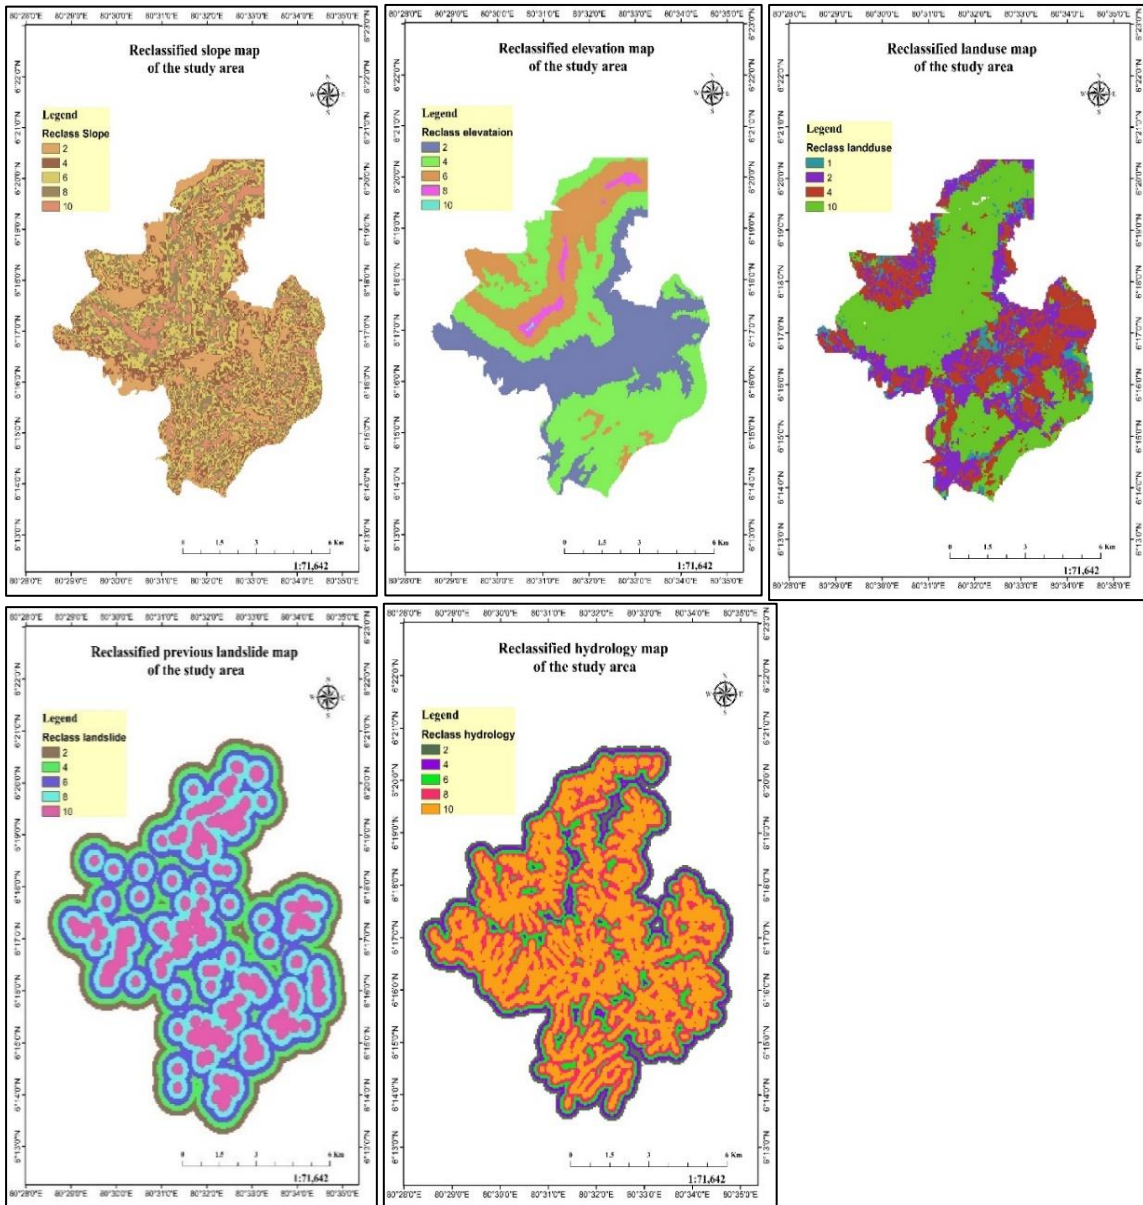
Figure 03: Reclassified maps of land use, elevation, slope angle, hydrology and previous landslides. Source: Prepared by the author using satellite data taken by the Survey Department, 2021.

Then, buffer zones were created surrounding the previous landslide areas with 200 meter intervals using the multiple ring buffer tool. Further, the buffer zone was created with 100 meter intervals to measure the distance from the stream. After creating these buffer zones reclassified into five new classes considering the proximity to water bodies or former landslides. The land use map also reclassified into five classes and a new score were assigned, according to the most affective land use type. Figure 03 shows the reclassified maps drawn to determine the weighted of land use, the elevation, slope angle, hydrology and previous landslides.

All reclassified layers of land use, elevation, slope angle, hydrology and previous landslides were overlaid by using the weighted overlay method giving the influence values in each factor. 30% for elevation, 25% for slope, 20% for land use, 15% for hydrology and 10% influence value for previous landslides were used to create the

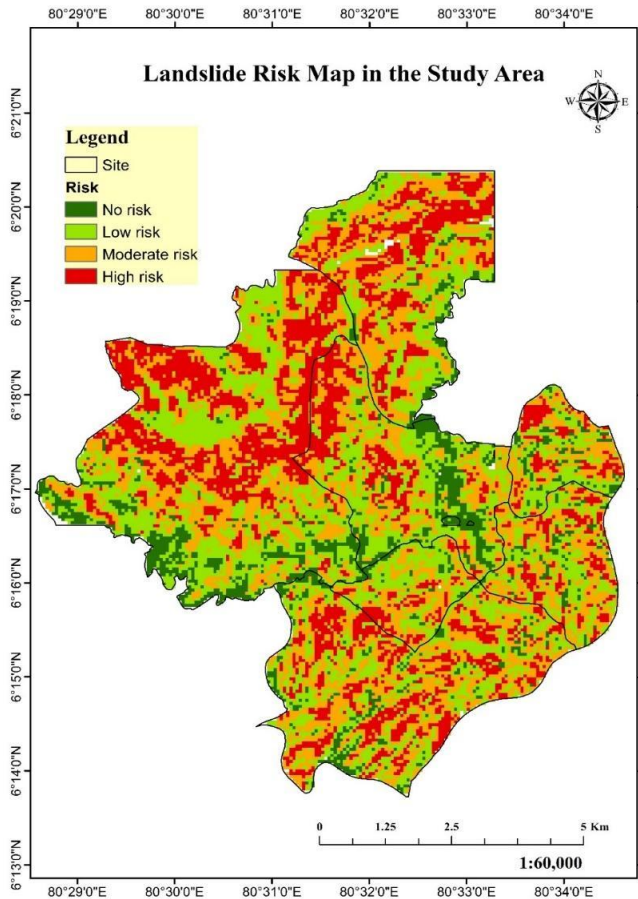
Figure 04: Landslide risk of the study area
Source: Prepared Using satellite data taken by the Survey Department of Sri Lanka, 2022

the criteria that are used to assess the landslide risk. Apart from this, in this research, five causative factors were used to compile the landslide risk map in the study area. The elevation, slope angle, land use, distance from previous landslides and distance from water resources are the factors used for the analysis and each factor is weighted based on the weight system used by NBRO (Pushpakumara et.al.2013). Table 01 shows the weights given in each factor to identify the potential risk areas and risk level. As shown in figure 04, the landslide risk zonation map is the result of the analysis carried out in the raster data model using the weight values of the obtaining factors using Arc GIS software and the risk areas which were identified using these criteria were further classified into four groups as high risk, moderate, low risk and no risk areas (Figure 04).

The following table 02 shows the total land extent of risk areas in this study area. According to the following table, there is a high landslide risk in 24% of land and it covers nearly 18 km² in this study area. According to the risk map, high risk zones are located throughout the entire area including Morawaka, Gatabaru Kanda, Diyadava, Horagala and Kosmodara. The right bank of the Morawaka Kanda landslide path in 2017, the upper part of Gatabaru Kanda, Deniyaya Watta in Diyadawa, Kohila watta-Henyaya in Horaga West were identified as high risk areas. These high-risk areas are approximately located in the high

elevation and consists of higher slope angles. Most of the above high-risk areas are occupied by tea or other cultivation and cleared areas as well as most of the previous landslides are reported in these areas.

distributed in the entire area. These moderate risk areas can be identified with a medium range of elevation and by improper land use practices in this area. Kotapola North, Morawaka and Horagala East areas have more moderate landslide risk areas than the other areas. Approximately, 55% of the lands in the study area tend to be high and moderate areas.

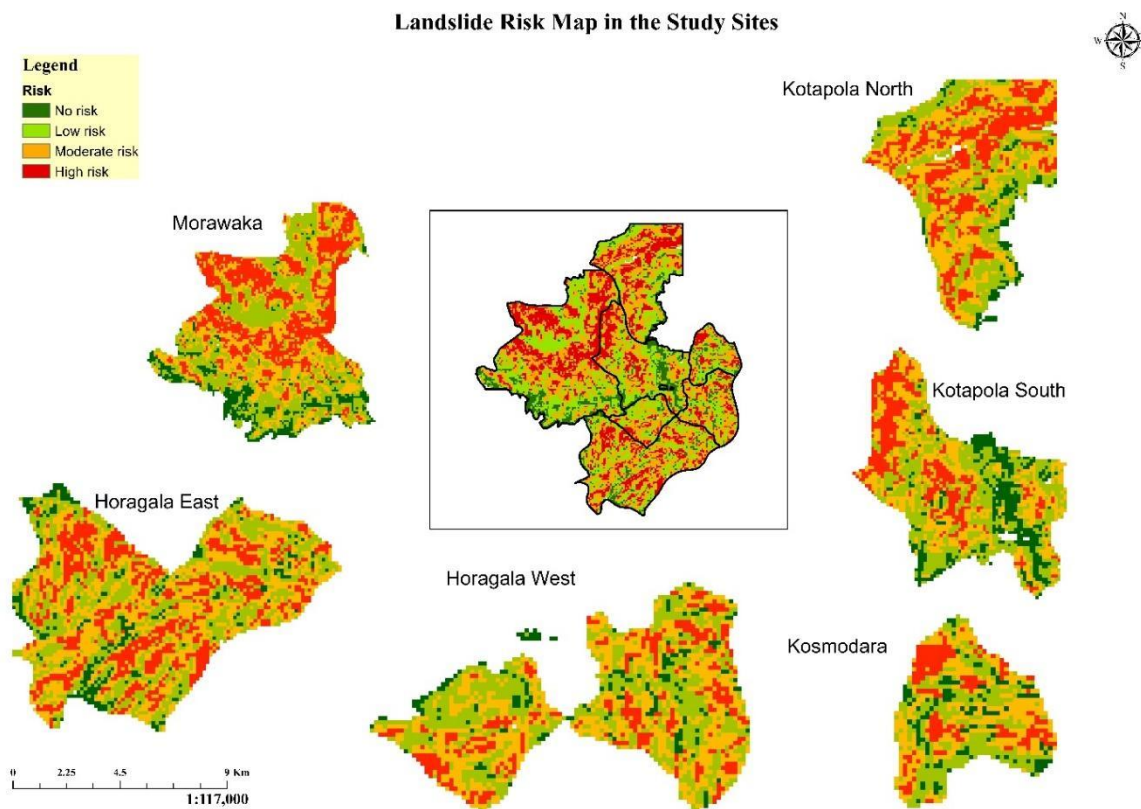
Figure 05: Landslide risk map in each site

When considering about the landslide risk in each area of this study area, the risk level of each site is varying from place to place. The above figure 05 shows the landslide risk of each site in this study area. According to the following table 03, it can be identified that the land extent of risk in each site is different. The largest amount of land is in the Morawaka kanda site area and it covers about 26.92km² land. The high risk in this area is about 7.53km² in extent, while nearly 12 km² land is in a

low risk or no risk level. According to the following table there is approximately the same land extent for high, moderate and low risk. However, mostly the top of the right bank of the Morawaka Kanda landslide path in 2017 and the surrounding hillside area is in the high-risk zone for future landslides. The foot of the Morawaka mountain and its surrounding flat and undulating lands are in a moderate or low risk zone for landslides.

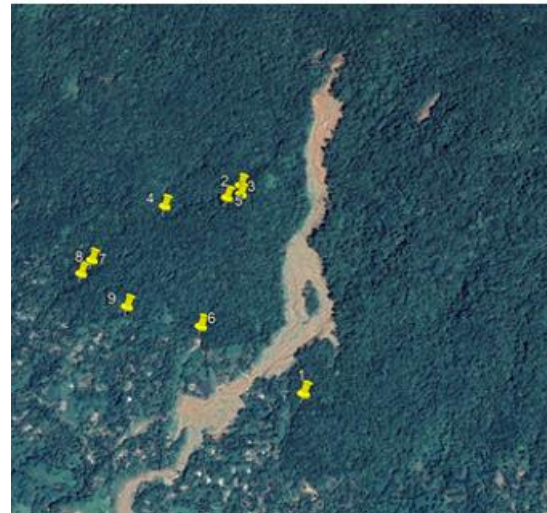
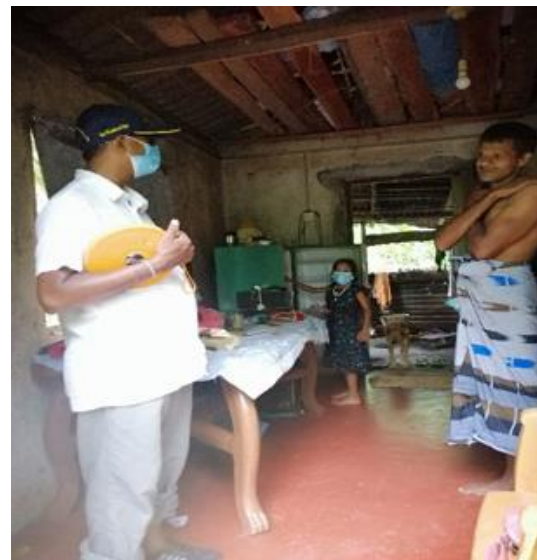
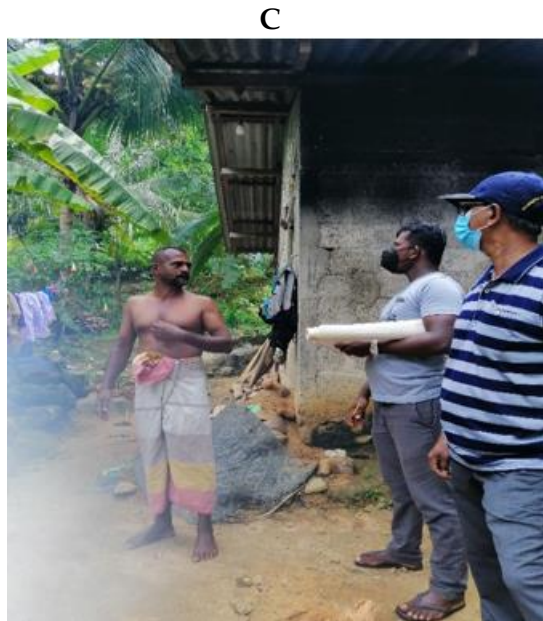
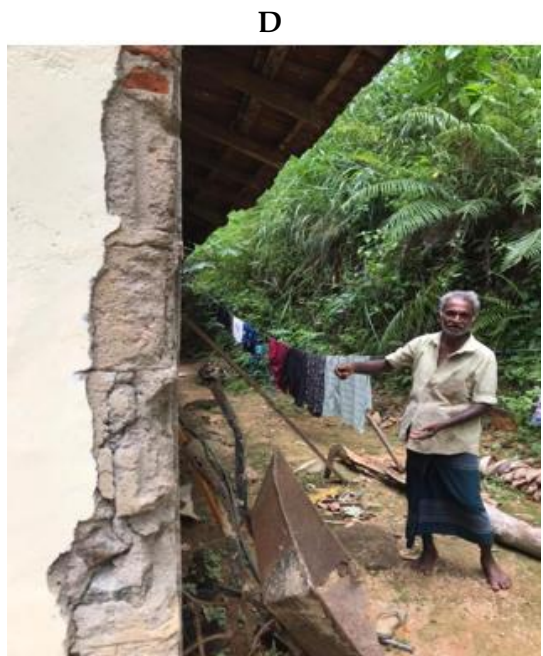
Figure 06: Houses for the landslide risk in the study area

- A. Risky houses in right bank of the Morawaka Kanda
- B. Risky house belong to the J.Y. Samantha in Morawaka Kanda
- C. Risky house belong to S.Jayasinghe in Diyadawa
- D. Risky house belong to Sunil in Horagala West

be identified at high risk. 50% of them are distributed in Morawaka Kanda and Yati Horagala. For example; the houses which belong to J.Y.Samantha, W.G.Nandawathi and Upali can be identified as high risk in Morawaka Kanda (Figure 06). Apart from this, the NBRO has identified nine landslide risk houses and locations in this area (figure 06 - A).

The houses which belong to Mr. H.K.Siripala, R.Dilip Rangana at Kohilawatta-Henyaya in Horagala West are also high risk houses with the crack of house walls, situated in higher slopes towards the stream valley and the emerging of springs on the ground in rainy periods. Although, the residents of these houses were informed to leave these houses, still they are living there, due to no safe places being provided yet. Accordingly, the people living in the risk area responded that unsafe areas is the most prominent factor for the future vulnerability for landslides. There are 21 responses for reluctance to move to safe areas while 31 respondents believe carelessness and negligence are also major causes for future vulnerability.
