## An Evaluation of the Land-Use Changes and the Associated Environmental Impact of Coastal Tourist Destinations: A Comparative Study of the Hikkaduwa and Bentota Sites

The study focuses on the analysis of land-use patterns and environmental impact in two coastal tourist destinations in the Southern coast of Sri Lanka: Hikkaduwa and Bentota. The aim was to assess how tourism has influenced land-use changes and the associated environmental problems. Primary and secondary data were collected through questionnaires, mapping techniques and remote sensing tools. The findings revealed significant transformations in both areas over time.

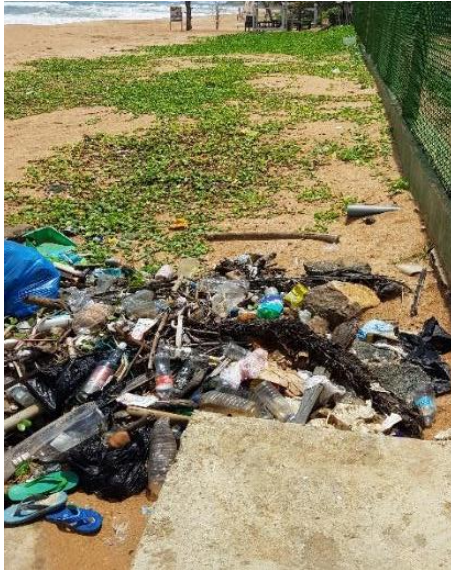
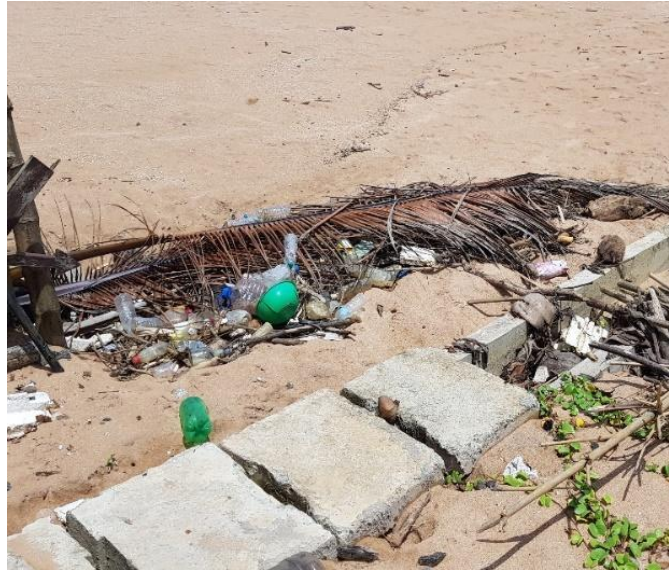
Exhibit 1: Irregularly dumped waste on the beach  
Source: Field observations, 2022

Hikkaduwa faces significant issues with unclean beaches, littered roads and land areas, which are commonly observed in the area. The community attributes this problem to multiple parties. Firstly, local tourists are identified as a primary contributor to the pollution of the beaches and land. Secondly, businesses associated with the tourism industry, including hotels, restaurants, and temporary shops, are

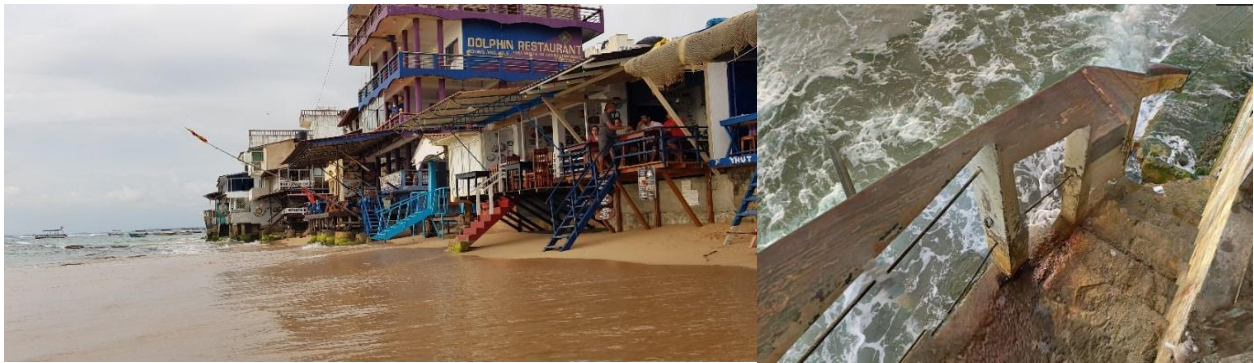
Exhibit 2: Coastal erosion in the north section of the Hikkaduwa beach  
 Source: Field observations, 2022

Coastal erosion is a significant problem in Hikkaduwa, resulting in the damage or loss of coastal structures, the loss of valuable land and the disruption of human activities like fishing and recreation. Some people believe that erosion has reached its maximum level and there is no more beach left to erode. As a result, it is difficult to find a clear, uneroded coastline from Hikkaduwa to Narigama for promoting coastal tourism. The community has noted that compared to the past, Hikkaduwa has smaller, scattered, and narrow beaches with no wide, continuous coastline.

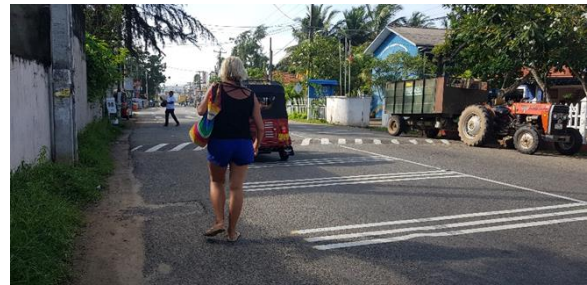
Exhibit 3: The absence of a sidewalk near the Hikkaduwa beach on the Galle-Hikkaduwa main road

The lack of a sidewalk on the A2 road has posed significant challenges, particularly in a tourist hotspot where thousands of tourists frequent the area. The absence of a sidewalk has resulted in a large volume of pedestrian traffic on the road, which is quite unsafe considering the presence of buses,

trucks, and lorries. Unfortunately, accidents involving tourists have occurred multiple times on this stretch of road. Compounding the issue is the limited space available due to buildings constructed close to the main road, making it impossible to widen the road and construct a sidewalk.

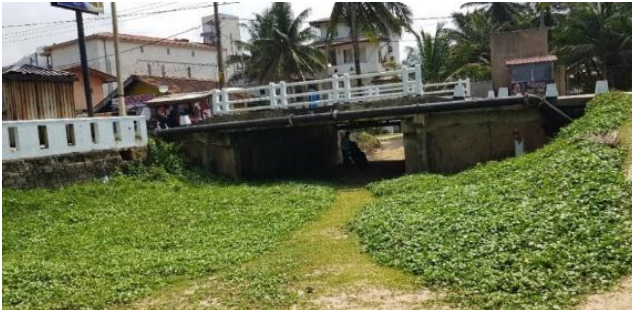
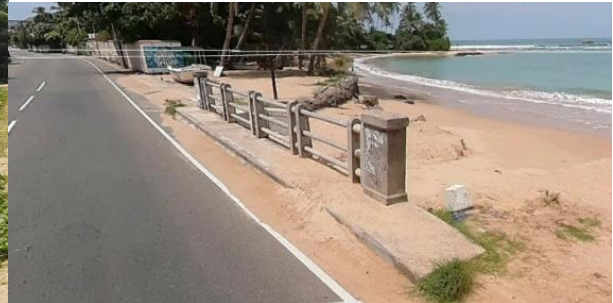
Exhibit 4: Outlets of Tuduwegoda canal (a) Mawakada canal (b) are filled with sand

One of the major environmental concerns in Hikkaduwa is the pollution of inland waterways that eventually connect to the sea. Within the study area of 36 km<sup>2</sup>, there are two canals, namely the Tuduwegoda Canal and the Mawakada Canal (Exhibit 4), which serve as outlets for excess rainwater to flow into the sea through the Hikkaduwa municipality. The Thuduwegoda Canal joins the Thelwatta ganga (Molapu oya) and empties into the sea from the Wavulugoda west GND, while the Mawakada Canal flows into the sea near the Hikkaduwa beach, where most tourist activities take place at the Pannamgoda GND (Exhibit 6). These canal outlets are periodically

obstructed by sandbar formations throughout most of the year, exacerbating the issue.

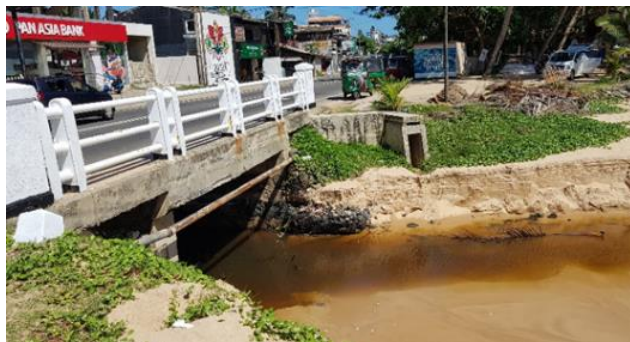
Exhibit 5: The Mawakada canal is connected to the sea by cutting the sandbank

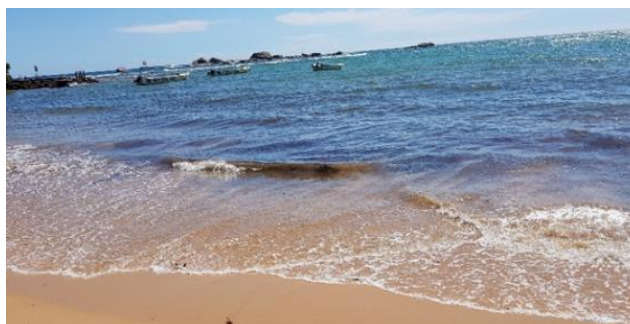
Exhibit 6: Dirty water from the canal has accumulated in the sea near the Hikkaduwa beach  
Source: Field observations, 2022

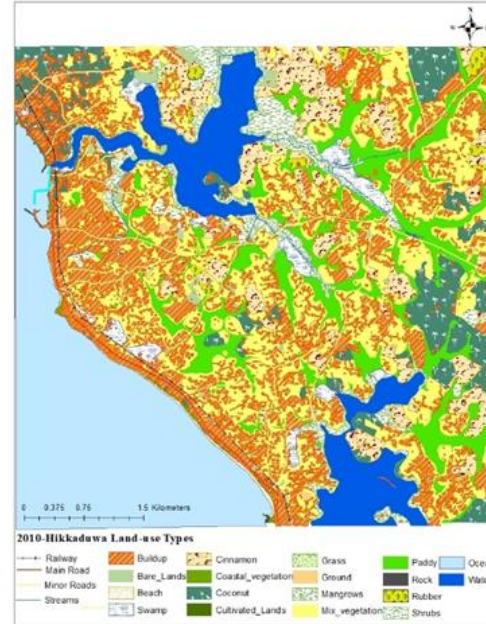
Figure 5: Land use maps of the Hikkaduwa area in 1984 (a), 2010(b), 2018(c), and 2022(d)  
 Source: Created by the author based on Google Earth images

shown in Fig. 5 depicting the land use changes in the selected area of Hikkaduwa from 1984 to 2022.

The Hikkaduwa anchorage consisted of a main breakwater (southward) that was developed into a fishery harbour during 1996-1998, adding up a secondary breakwater, inner and outer breakwaters attached to the main breakwater and a groin in the basin. After the Tsunami disaster, during 2005-2007, the inner breakwater extension was done to minimize the sand entering the harbour basin. The breakwaters built around the fishing harbour from land to sea have increased the land area by 6 hectares in 2010. Therefore, in the maps created in 2010 and thereafter, the land area is shown as 2833 hectares. After 16 years since 1984, by 2010 many changes in land use can be detected in this area again. The built-up area has increased to 21.11%, which is an increase of 11.51% compared to 1984. Also, the area under cinnamon has increased to 6.88%. Compared to the growth of

buildings and cinnamon-cultivated land areas, mixed vegetation, paddy fields, coconut, and rubber-cultivated land areas have decreased gradually and percentagewise they can be identified as 27.07%, 12.88%, 9.06%, and 0.87% respectively. The beach land has further decreased by 0.35% as compared to 1984. Thus, it appears that by 2010, land use of mixed vegetation, paddy fields, and coconuts has gradually turned into built-up areas.

Eight years later, in 2018, the areas with buildings and cinnamon cultivation have further increased to 34.95% and 7.56% respectively. Meanwhile, the land area cultivated with mixed vegetation, rice paddy, coconut, and rubber has further decreased to 17.94%, 8.59%, 7.72%, and 0.55% respectively. Beach land decreased by 0.24% in 2018 compared to 2010.

By the year 2022, the area with buildings represents 37.17% of the total land area, and the area under cinnamon cultivation represents 8.79%. In addition to this, the amount of tea cultivation area that has been identified as a new crop since 2018 has grown to 0.53% by 2022. In contrast to this, it can be recognized that the amount of mixed vegetation, rice fields, coconut, and rubber lands is continuously decreasing. By 2022, buildings are the dominant land use type in the area.
